Re: 555 Main Street, Roosevelt Island NY - Elevators - VDA No. 8213

INITIAL ELEVATOR EVALUATION

555 MAIN STREET

ROOSEVELT ISLAND, NEW YORK

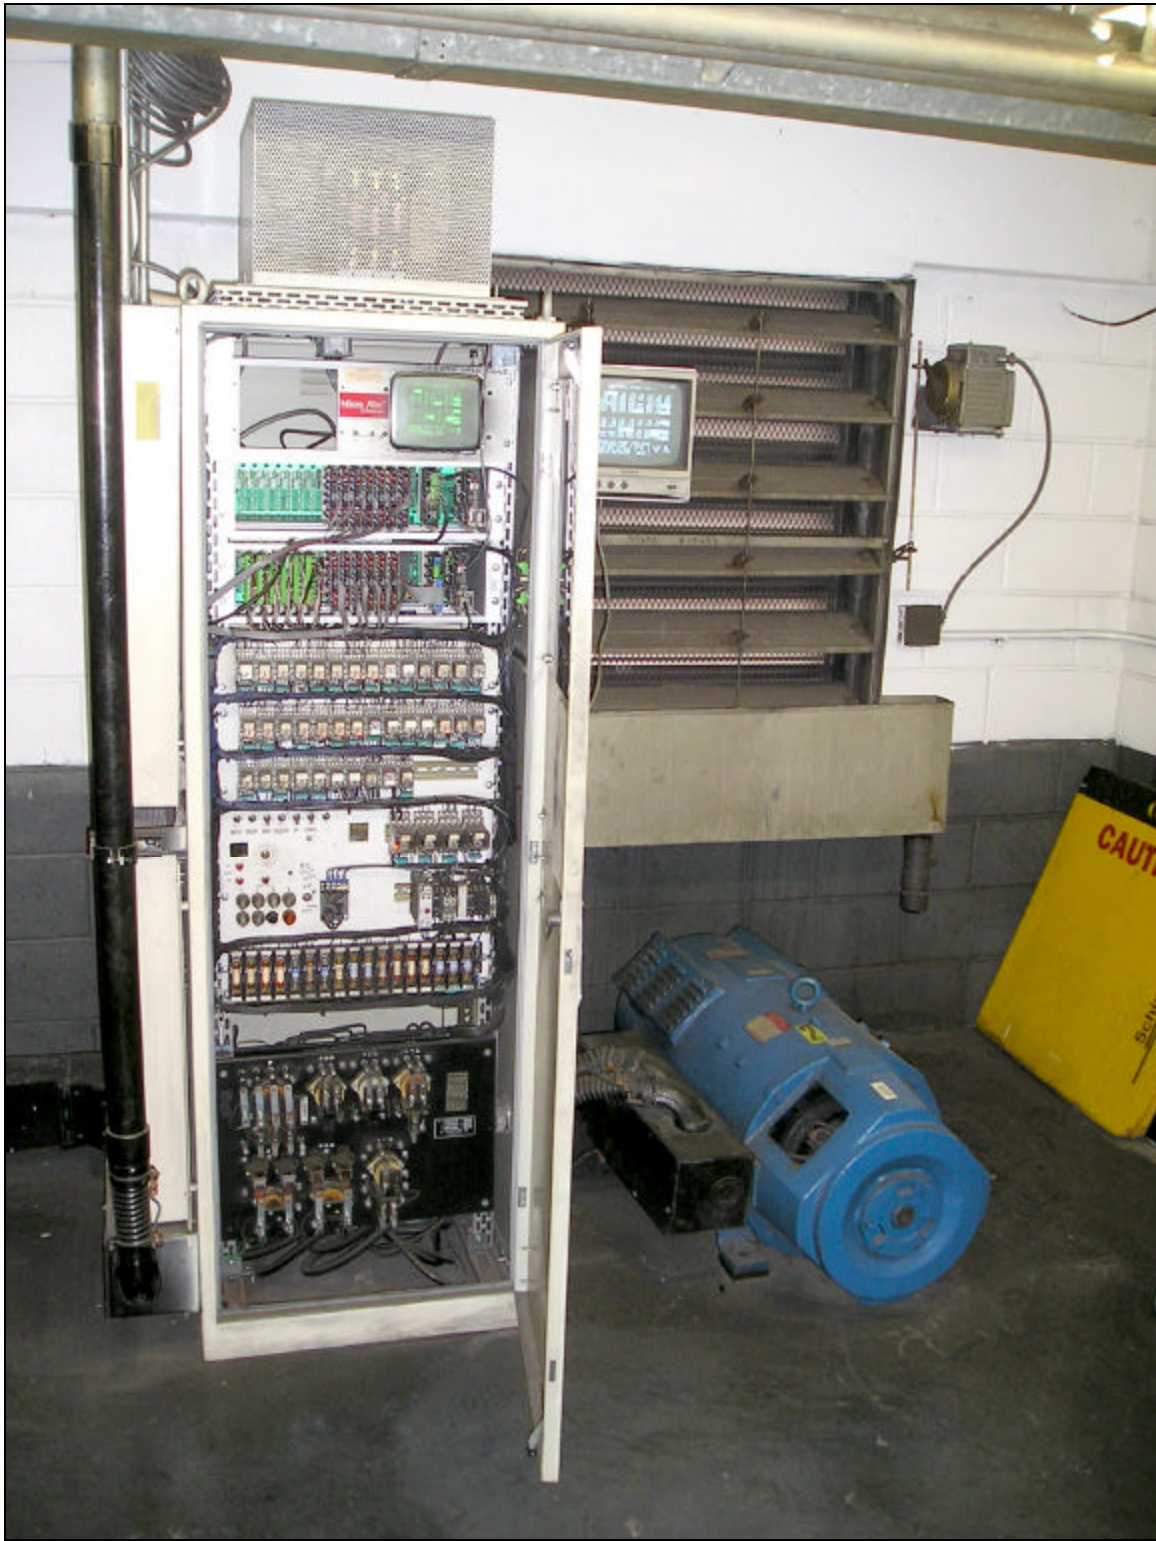
Photo No. 1
May 11, 2005

The original Imperial motor-generator, as installed by Serge Elevator are in operation. In general, the motor-generators appear to be in satisfactory condition. However, unlike the gearless traction machines, the motor-generators are subjected to more use and are less robust. It is recommended that the existing motor-generators be replaced with new SCR motor-drives, as part of the proposed modernization.

South Elevator No. 2, Controller and Motor-generator
555 Main Street, Roosevelt Island

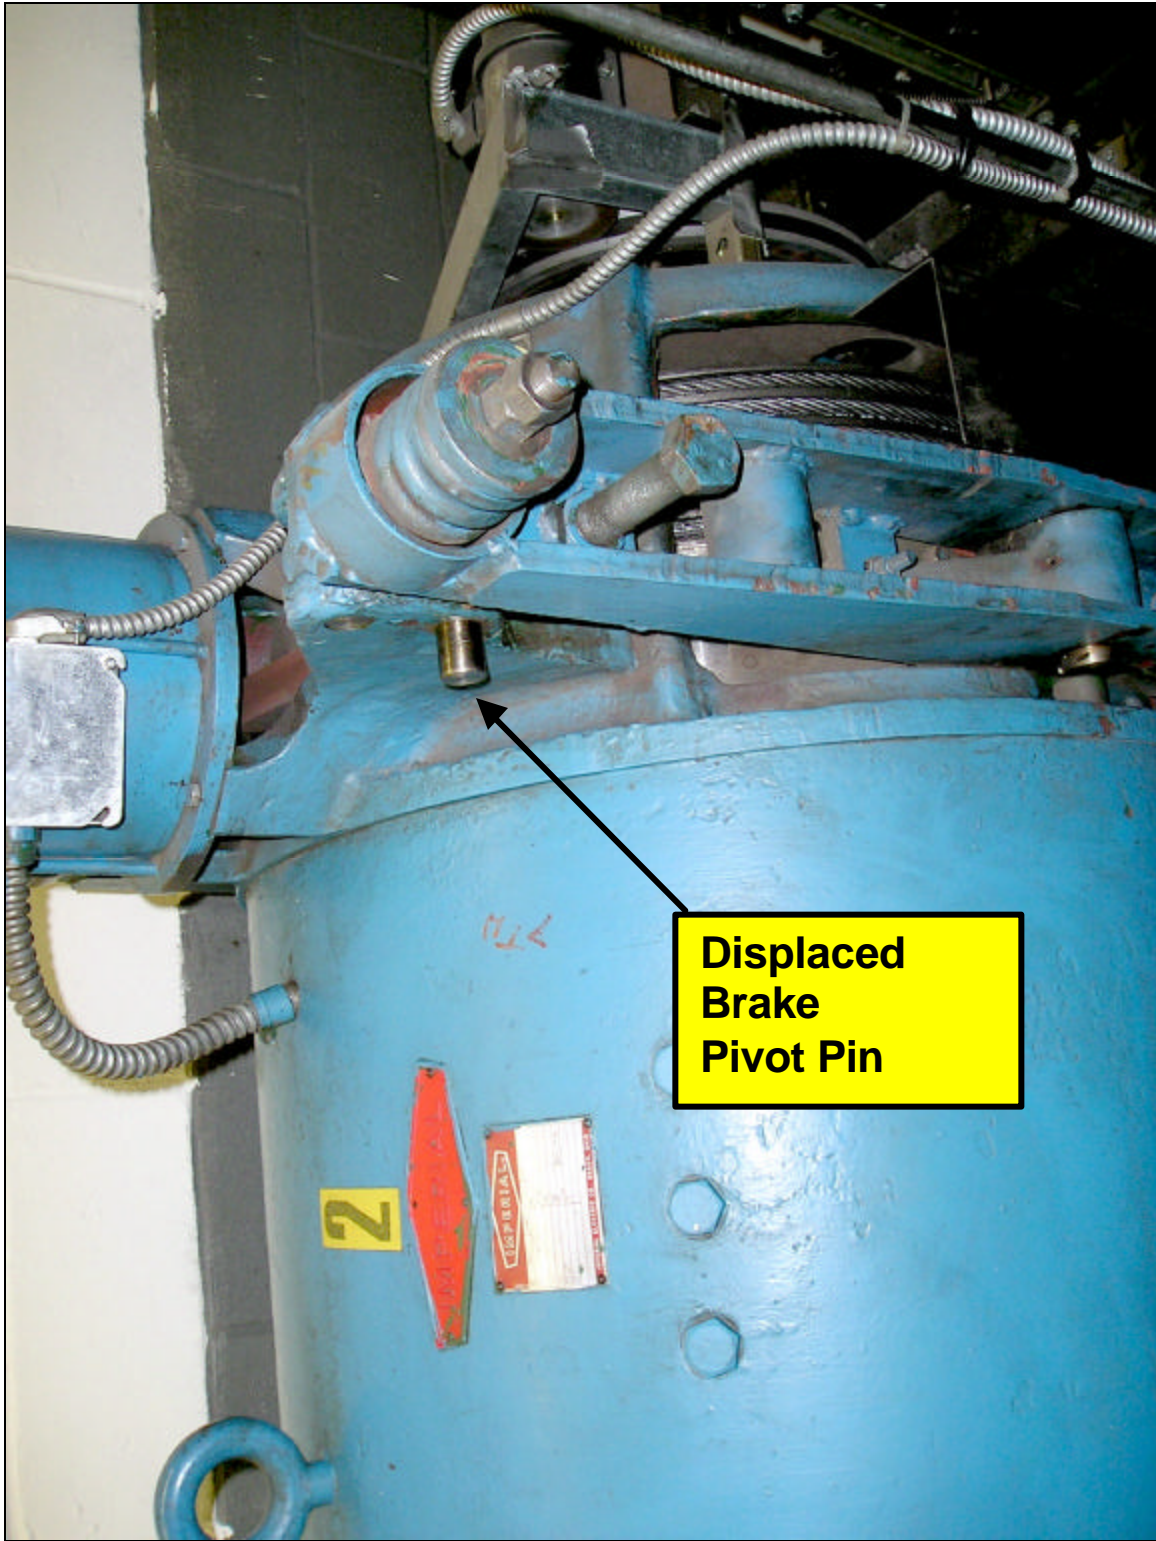
Photo No. 3
May 11, 2005

The pivot pin for the brake assembly of South Elevator No. 2 is displaced and requires adjustment. This condition should be corrected **immediately**. The No. 2 hoist rope (counted from the armature) for South Elevator No. 2 appears to be low in the traction sheave, indicating wear to the traction sheave. In general, the hoist ropes and traction sheaves should be inspected for wear by the elevator maintenance provided.

1. Hoist motor commutator is dirty.
2. Hoist rope is low in groove of traction sheave. Verify condition of traction sheave and hoist rope equalization.
3. Brake pivot pin is displaced and requires immediate attention.
4. Car door rollers appear to be worn.

South Elevator No. 2, Displaced Brake Pivot Pin
555 Main Street, Roosevelt Island

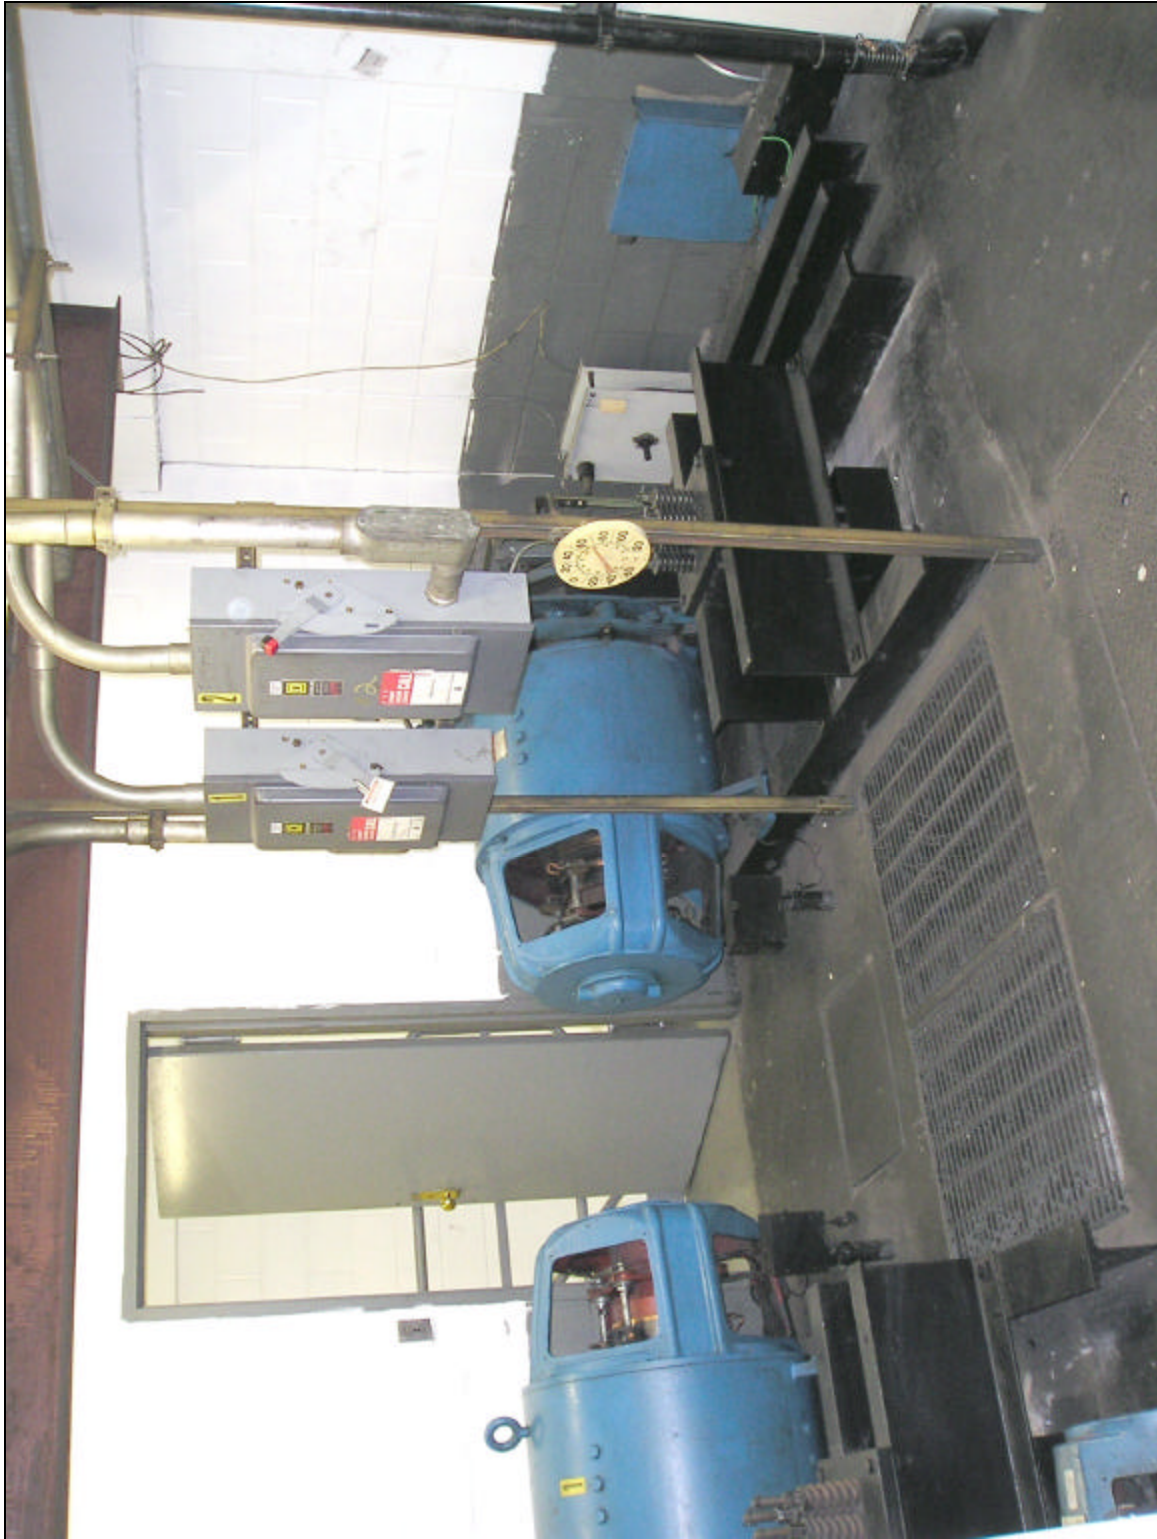
Photo No. 4

The original Imperial gearless traction hoist machines, as installed by Serge Elevator are in operation. In general, the hoist machines are in satisfactory condition and with overhauling and proper maintenance the life expectancy could be increased, allowing their retainage and reuse, should a modernization be undertaken.

South Elevator Machine Room, Hoist Machines

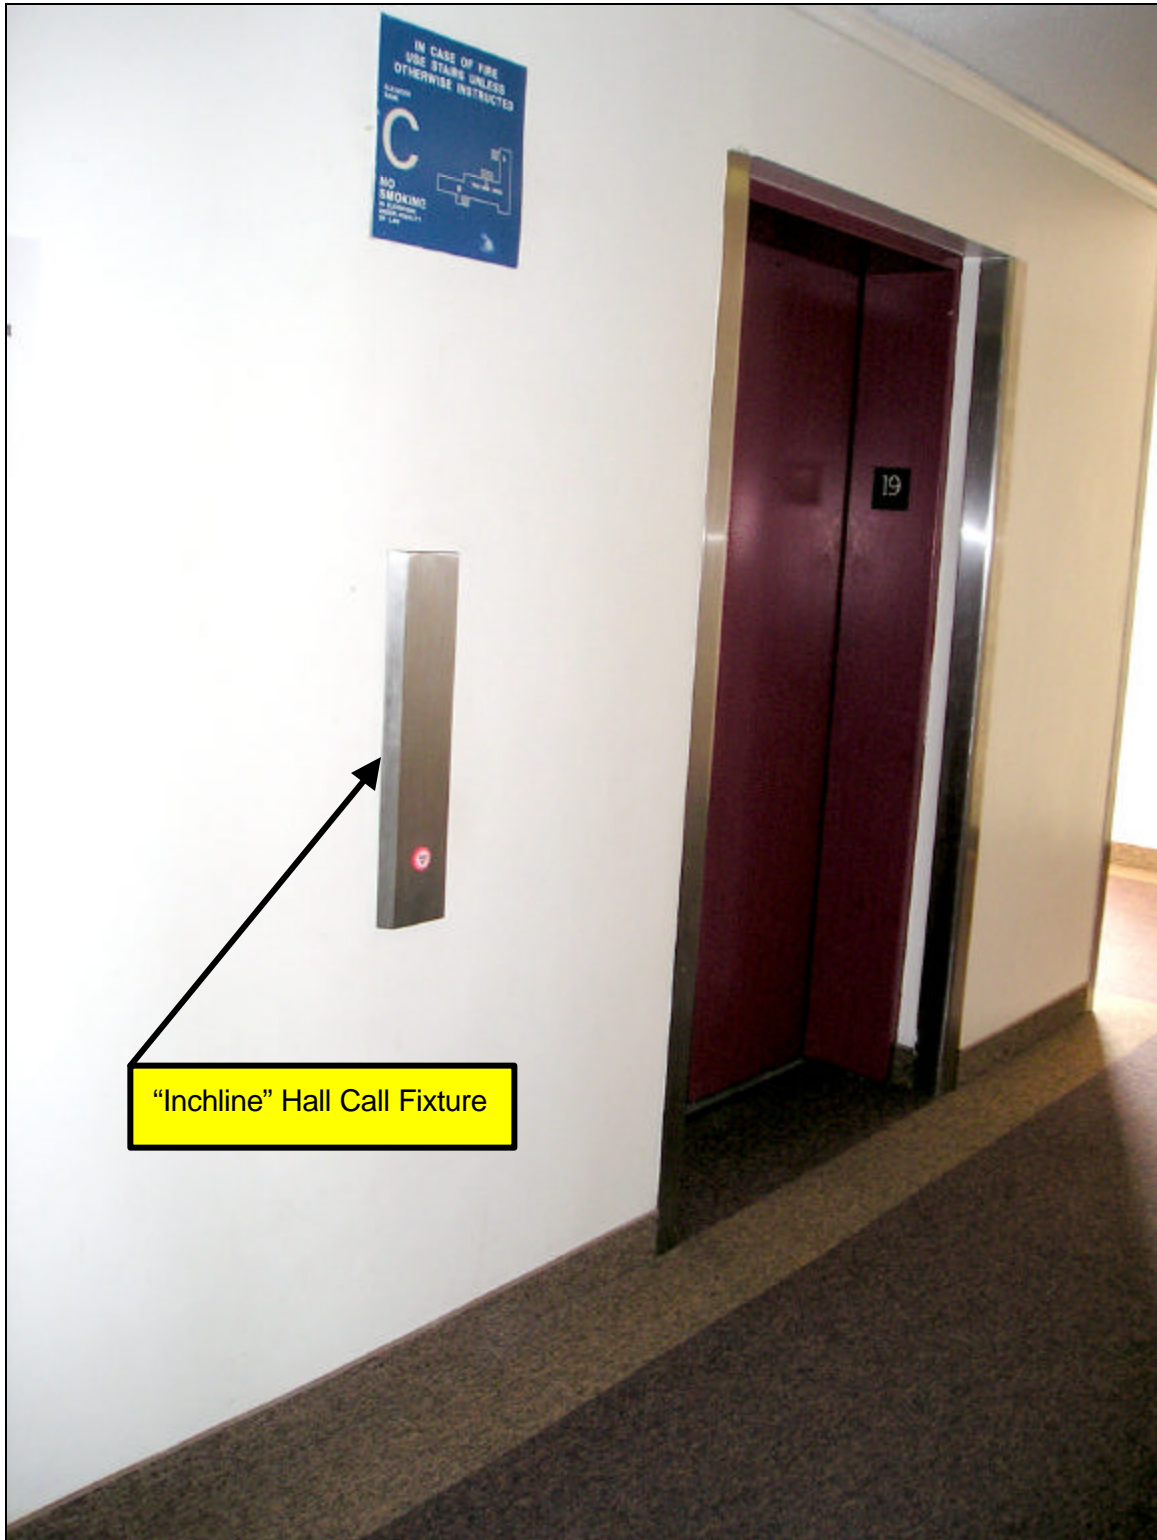
Photo No. 5
May 11, 2005

The hall push buttons for the North Elevators are furnished with cover plates, which are flush with the wall surface. The South Elevators are provided with "Incline" fixtures which are surfaced mounted. Most of the fixtures are not at the correct ADA height. We recommend new handicapped compliant fixtures be provided, as part of the modernization.

"Incline" Hall Call Fixture

South Elevator No. 2, at 19th Floor
555 Main Street, Roosevelt Island

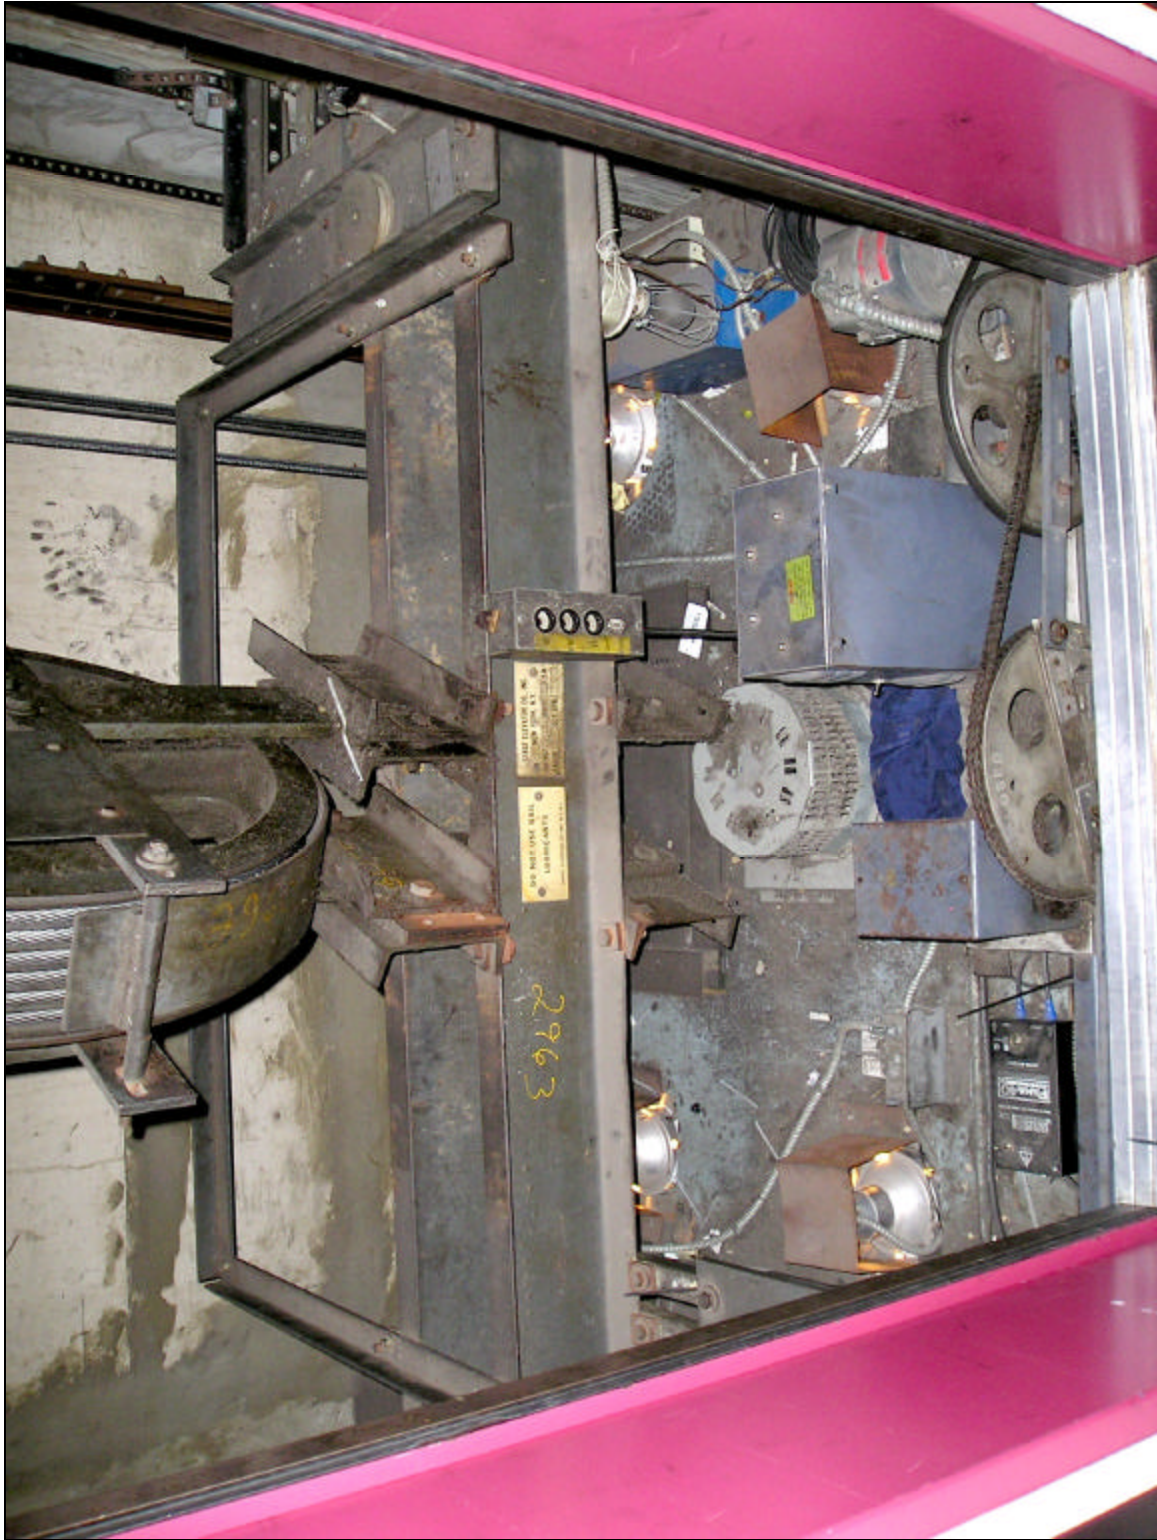
Photo No. 6

South Elevator No. 2, Top of Elevator Car

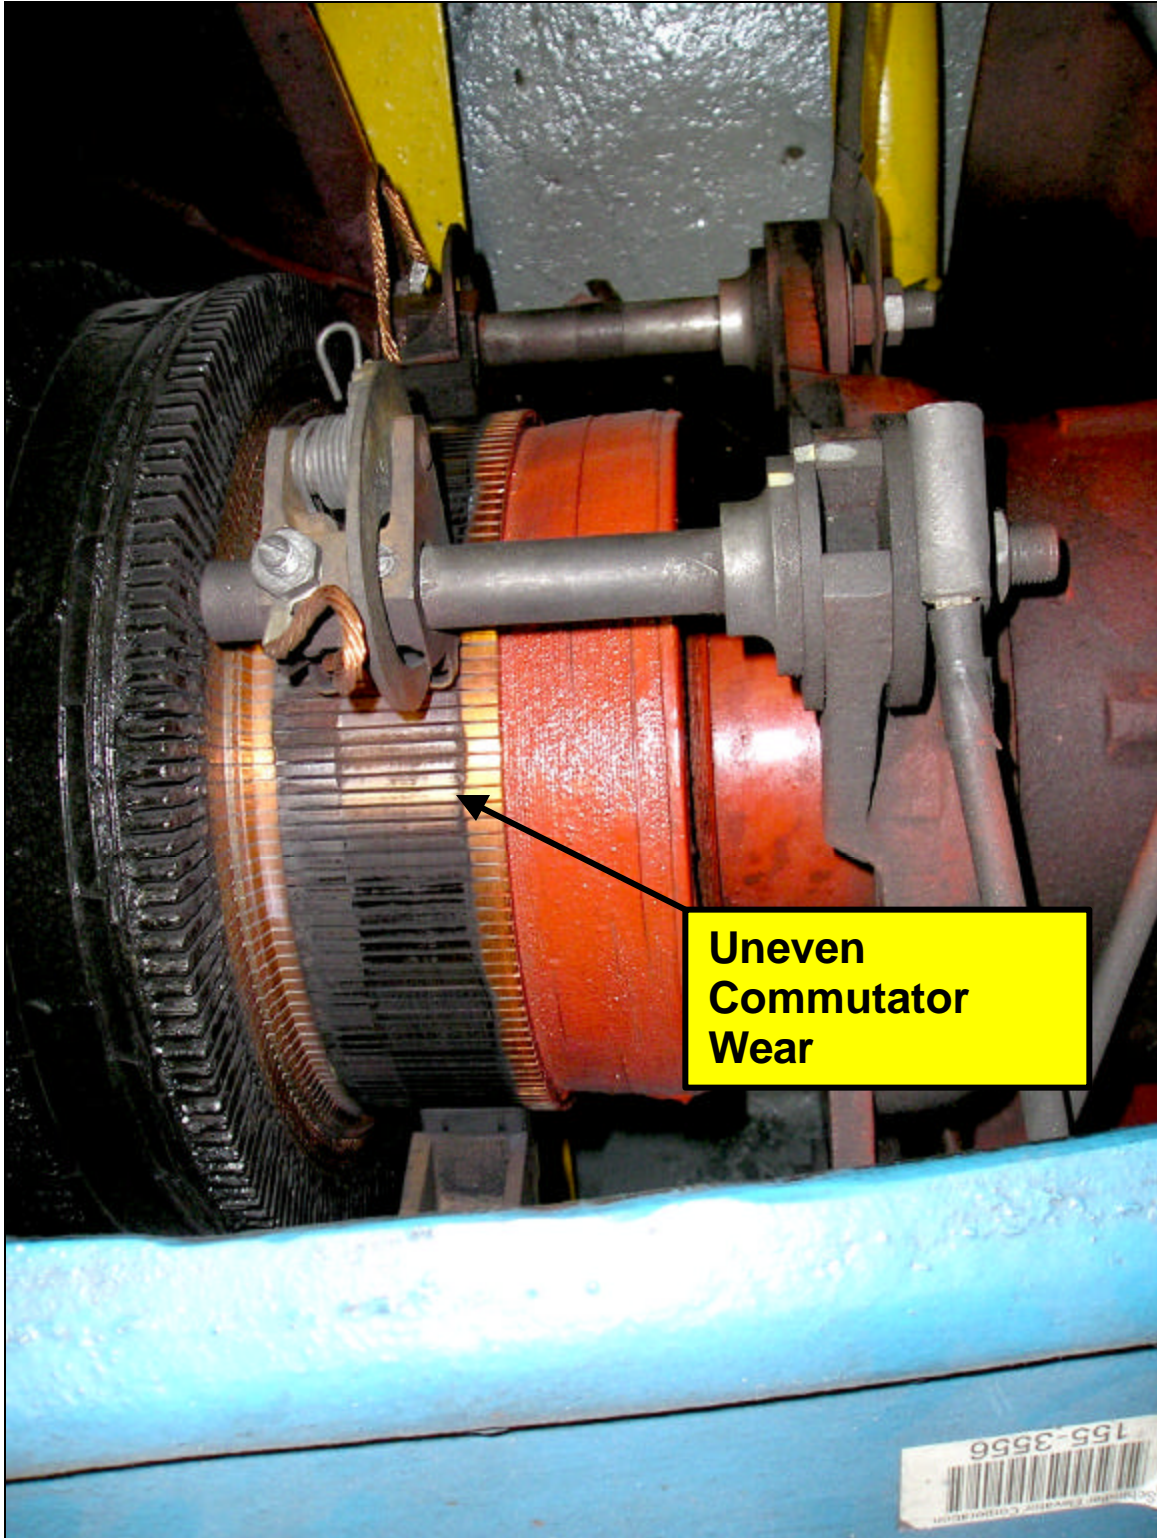
Photo No. 7

North Elevator No. 2, Hoist Machine Commutator

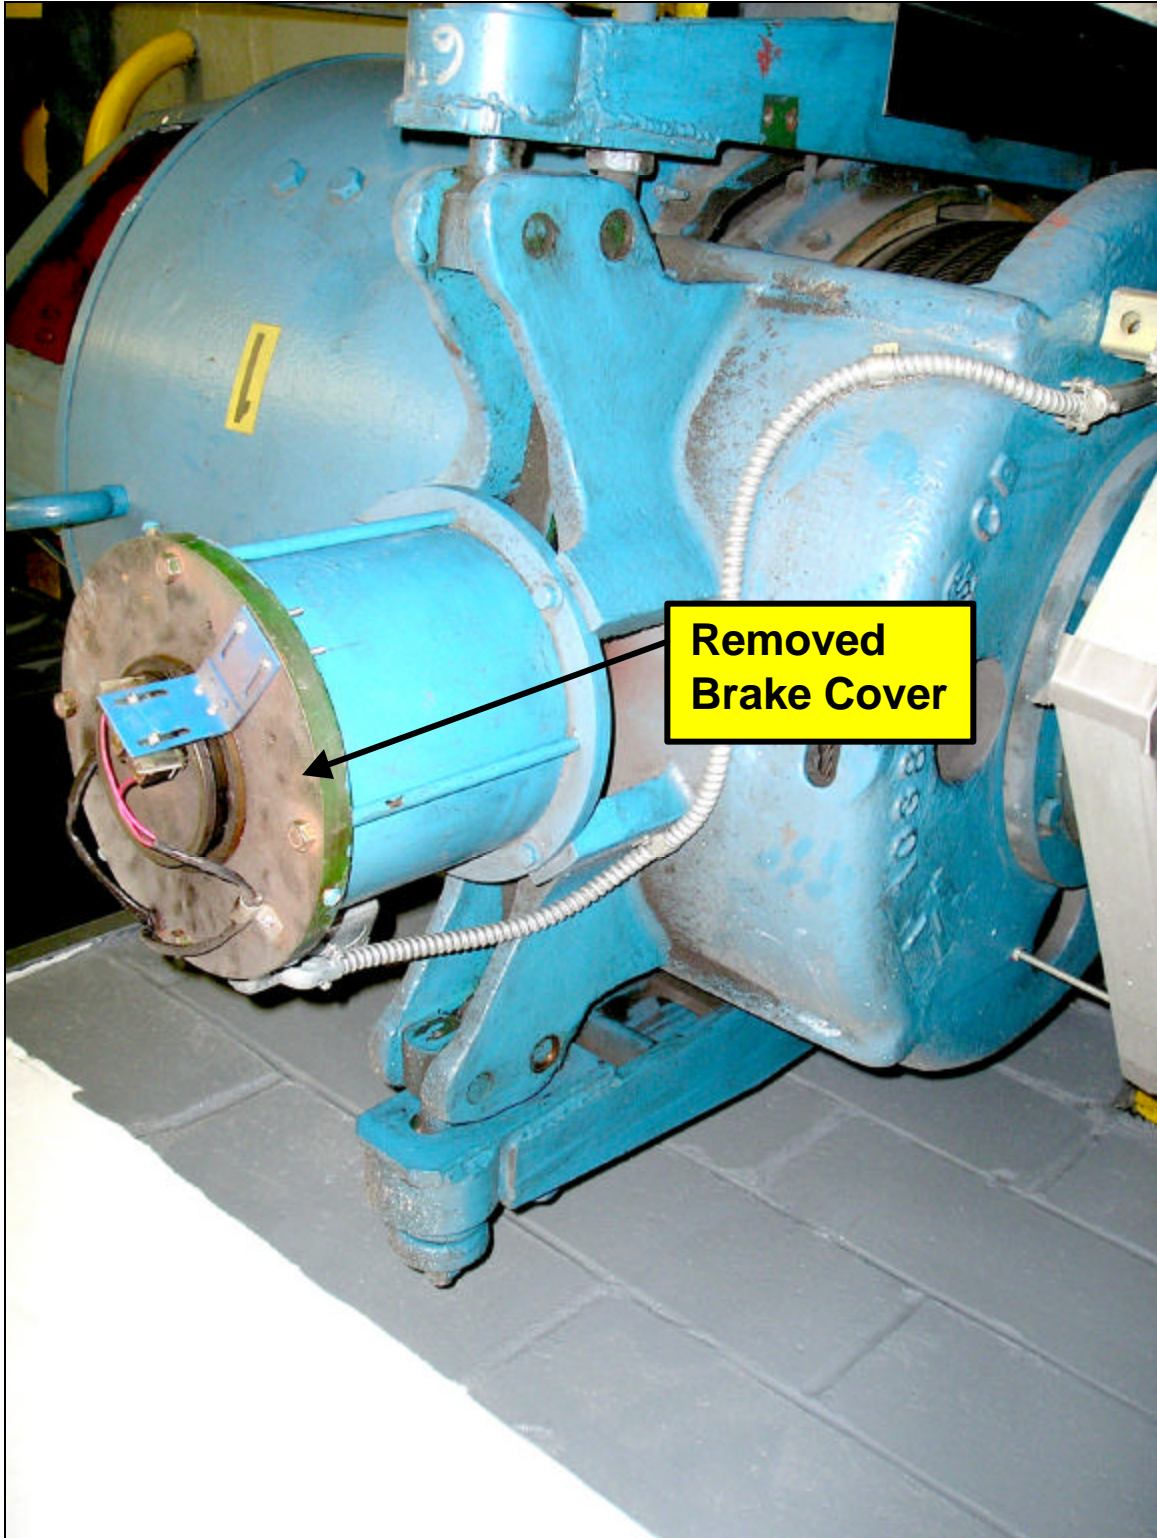
Photo No. 8

1. Motor-generator has commutator chatter.
2. Brake cover removed.

North Elevator No. 1, Brake Cover Removed

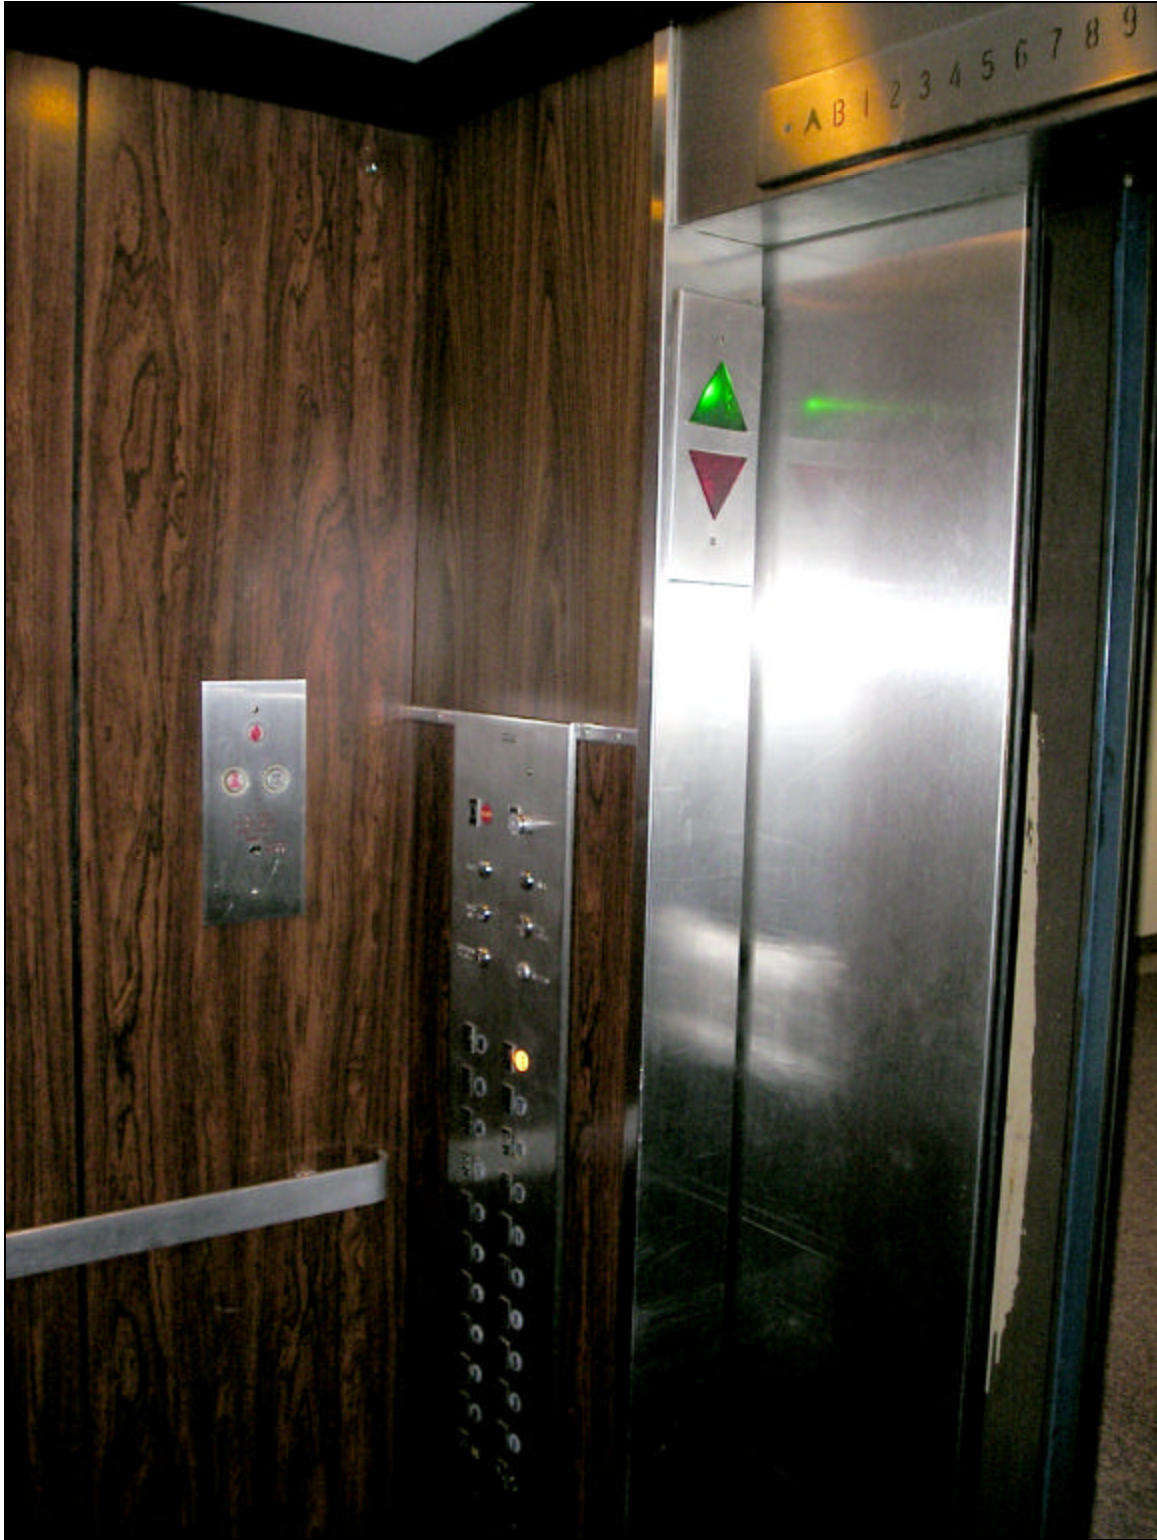
Photo No. 9

The car operating fixtures are in satisfactory condition. The car operating panels are not located in accordance with ADA requirements. New car fixtures are recommended as part of the proposed modernization.

South Elevator No. 2, Car Operating Panel
